## **Guarding of staircases and landing – some contractors still failing to meet basic standards**

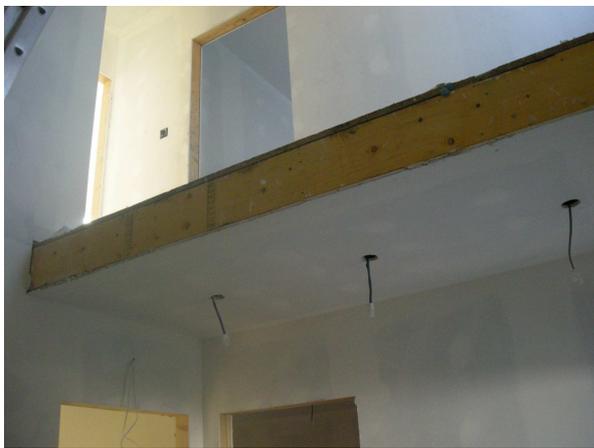
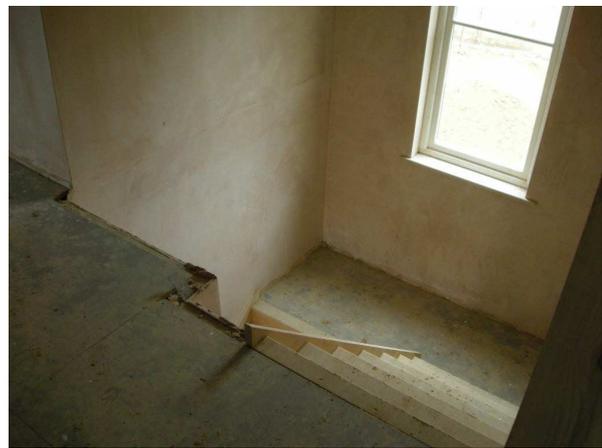
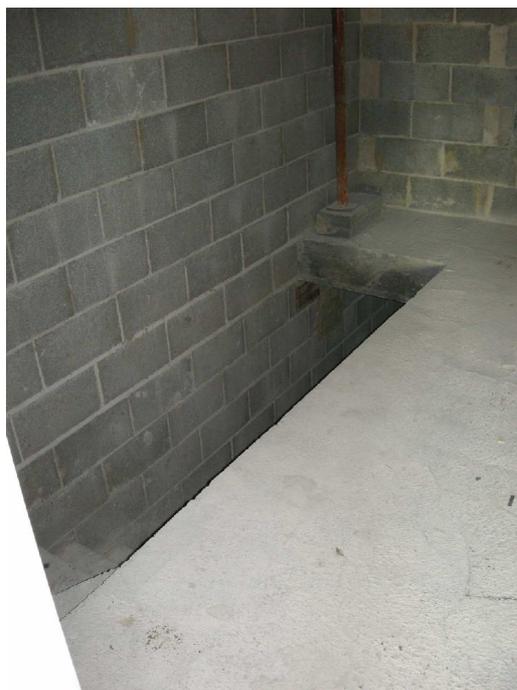
In response to this, a number of focussed inspections were carried out in early 2008 to review the standards in the industry. The photographs below illustrate some of the poor practices identified which required immediate attention due to the risks involved. Although in these examples, the handrails had clearly never been fitted, in many instances it was identified that handrails had been removed to enable the transfer of materials etc. but had not been put back once this was complete.

The legal requirements relating to the guarding of stairs are contained in Part 10 of the Construction (Safety Provisions)(Jersey) Regulations 1970, a guide to which is available on this website under 'Guidance on Legislation - Law and Regulations'. In essence, stairs and landings must be guarded to prevent persons from falling from any edge and in circumstances where handrails are removed, such as to allow the movement of materials, they must be put back as soon as this work is finished.

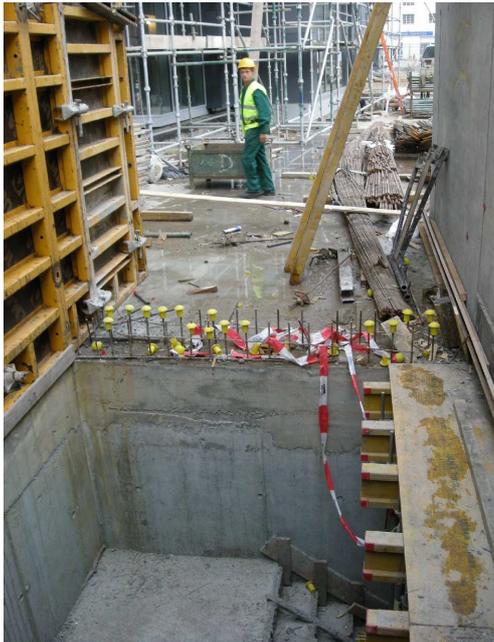
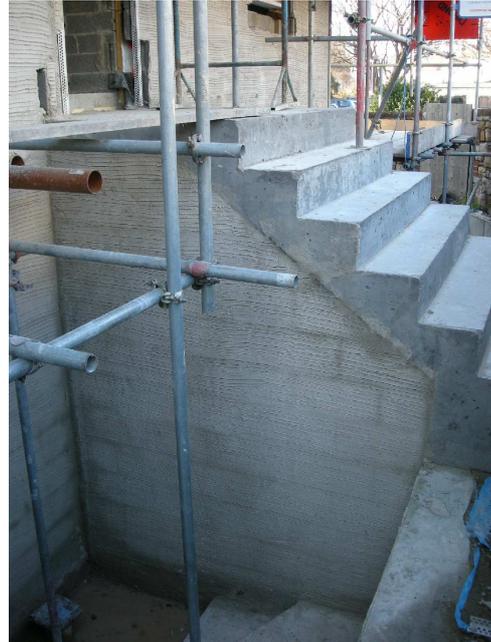
In addition to internal staircases and landings, it is necessary to give the same consideration to those which are external, which is often lacking, as demonstrated by the photographs below.

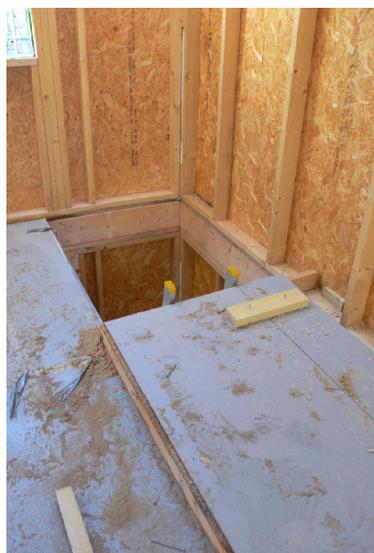
If the opening for the stairs is not used as a means of access, then ideally it should be boarded over in a suitable manner. In such cases, it is essential that the boards are secure and adequately supported from below. This has the added advantage that it provides a safe working platform from which work to the walls forming the stairwell can be carried out. If the stairwell is used as a means of access, then either handrails should be erected to the exposed edges (except where persons are gaining access to and from the ladder) or the opening can be boarded over to reduce the size of the opening, as shown below. It should be noted that where ladders are used for access, they must extend 3 feet 6 inches above the landing place unless there is another suitable handhold available

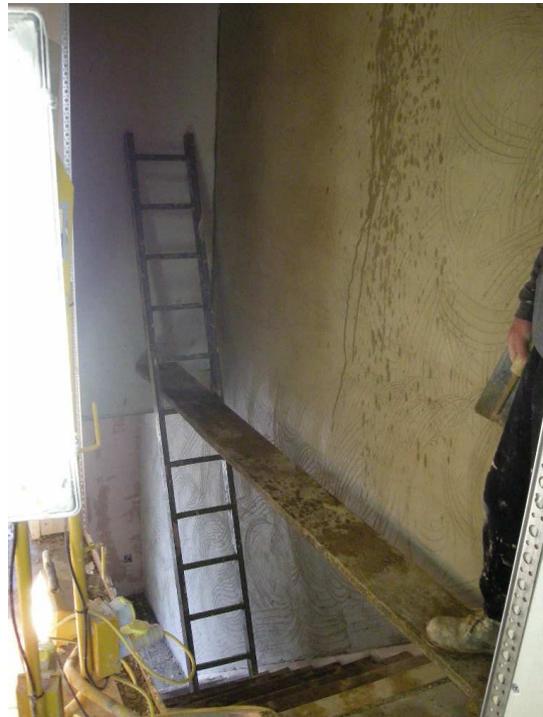
As well as managing the presence of these openings in floors, work to the walls of the stairwell also poses a particular problem for contractors in terms of safe access. It is vital that the sequence of works is carefully considered and the system of work used is properly planned. Unfortunately, the arrangement shown in the photograph below is all too common. This is entirely unacceptable and action will be taken where this type of practice is observed.

It was a similar practice to this, approximately 2 years ago, which resulted in an individual sustaining severe injuries including a fractured skull when the ladder slipped. The employer was successfully prosecuted for failing to provide a safe system of work but the repercussions were far greater for the individual, who was absent from work for several months and unable to take part in the social activities he enjoyed.

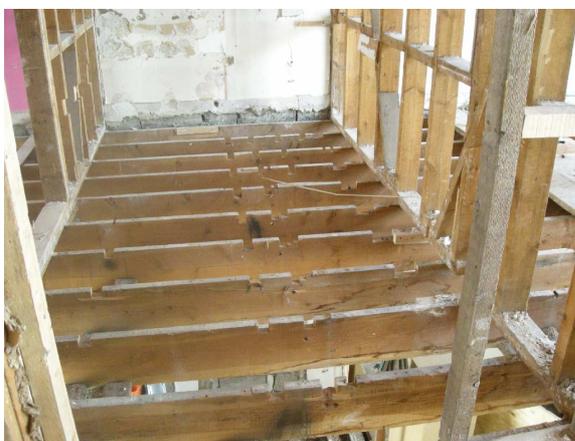
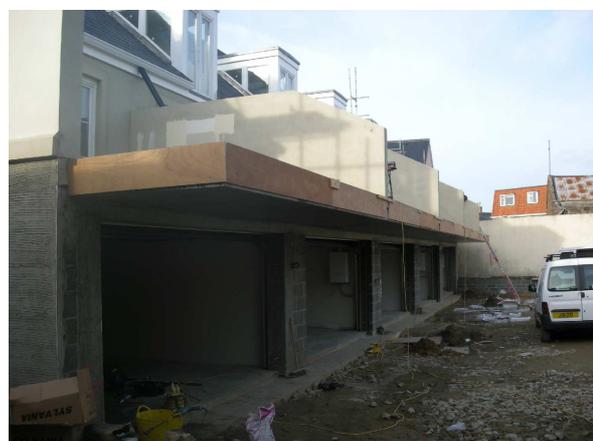
Some positive findings in respect of the guarding of stairwells were identified during the focused inspections and also evidence of good practice was observed on a number of the sites visited. However, on at least two sites, serious issues regarding work at height were identified as shown below.

Persons observed working in both of these areas were immediately stopped and the failure to manage these works constituted a breach of health and safety legislation which exposed the individuals concerned to a risk of serious personal injury.
